HA-1114
BATA SHOE BUILDING
Havre de Grace, Md.

INVENTORY FORM FOR STATE HISTORIC SITES SURVEY

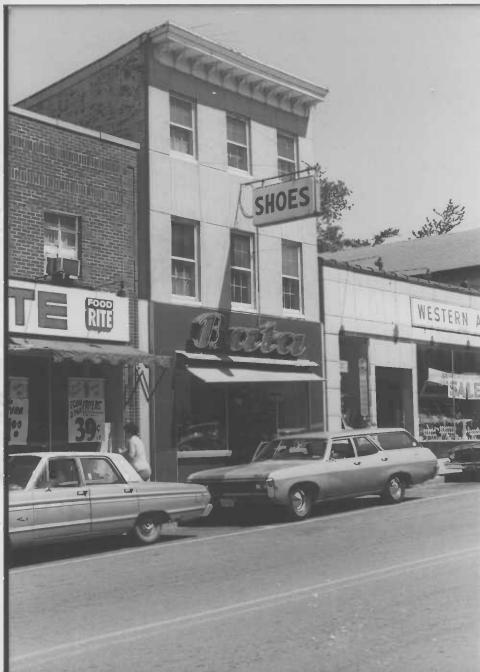
14A-1114 BATA SHOE BLDG. 131 N. WASHINGTON HAVES de GRACE WEST ELEV MARION MORTON MAY 77

The Bata Shoe Building is a late 19th century three story, three bay, brick commercial building with brick buildings on either side. The front elevation, facing west on N. Washington St. is covered with lime green stucco which is scored to resemble large blocks of smooth faced stone. The flanks are brick and the stucco veneer was added in the late 1940's.

Windows, having 6/6 double hung sash, are spaced evenly in the facade on the second and third floors, windows on the second floor being larger. A plastic tile store front covers the building below the second floor. In the center is a door flanked by plate glass display windows. There are no windows in the flanks.

The roof is flat and slopes towards the east. A box cornice supported by brackets with pendants is the most decorative element on the structure.
